Rooftop Maintenance & Equipment Cleanup

Rooftop cable management remediation, redundant 48V cable decommissioning, and obsolete Ubiquiti WiFi receiver removal at Richmond facility.

Job Number: JN 3752 **Customer:** The Phillips Group **Location:** 19 Howard St Richmond VIC 3121

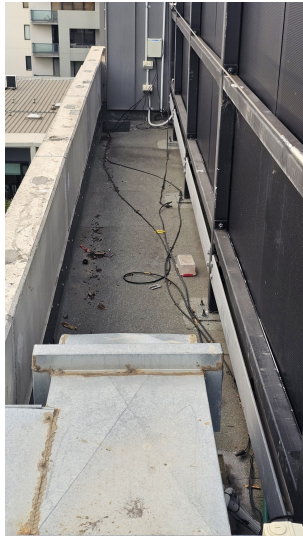
Current Condition

Cabling has been moved from its original secured position and is now loose along the concrete wall, creating a **significant tripping hazard**. This appears to have been caused by roof repairs in the past. Proper **cable clips and management** are required to secure all loose cabling and eliminate this safety risk.

- **Professional cable clips** installed along concrete wall
- **Secure mounting** of all loose cabling
- **Safety compliance** ensuring no tripping hazards remain
- **Clean professional appearance** with organized cable runs
