## Rooftop Maintenance & Equipment Cleanup

*Rooftop cable management remediation, redundant 48V cable decommissioning, and obsolete Ubiquiti WiFi receiver removal at Richmond facility.*

**Job Number:** JN 3752 **Customer:** The Phillips Group **Location:** 19 Howard St Richmond VIC 3121

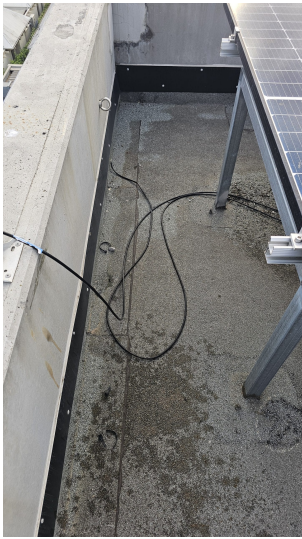
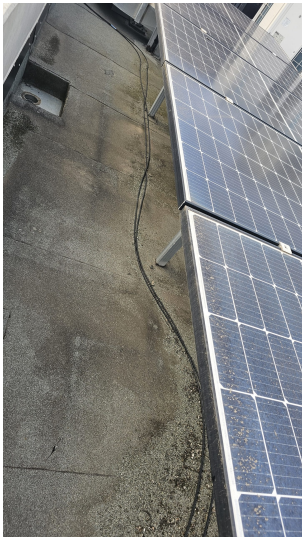
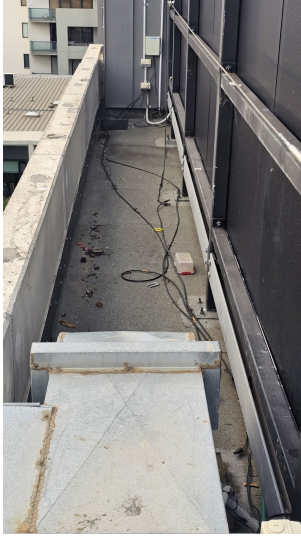
#### Current Condition

Cabling has been moved from its original secured position and is now loose along the concrete wall, creating a **significant tripping hazard**. This appears to have been caused by roof repairs in the past. Proper **cable clips and management** are required to secure all loose cabling and eliminate this safety risk.

- **Professional cable clips** installed along concrete wall
- **Secure mounting** of all loose cabling
- **Safety compliance** ensuring no tripping hazards remain
- **Clean professional appearance** with organized cable runs

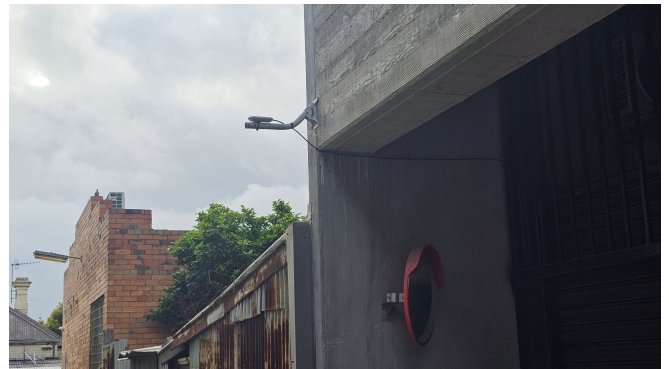
The **Ubiquiti WiFi receiver** on the ground floor used to receive signal from the rooftop but has been redundant since your upgrade to a **dedicated NBN connection**. Clean removal of this obsolete equipment and tidying of all associated cabling is included.

Ubiquiti WiFi Receiver on Ground Floor - No Longer in Use

- **Complete removal** of redundant Ubiquiti WiFi receiver
- **Cable tidying** and removal of unused connections
- **Clean finish** with no visible remnants
- **Professional appearance** after equipment removal
